EASA	AIRWORTHINESS DIRECTIVE	
 	<p>AD No.: 2014-0133</p> <p>Date: 27 May 2014</p> <p>Note: This Airworthiness Directive (AD) is issued by EASA, acting in accordance with Regulation (EC) No 216/2008 on behalf of the European Community, its Member States and of the European third countries that participate in the activities of EASA under Article 66 of that Regulation.</p>	
<p>This AD is issued in accordance with EU 748/2012, Part 21.A.3B. In accordance with EC 2042/2003 Annex I, Part M.A.301, the continuing airworthiness of an aircraft shall be ensured by accomplishing any applicable ADs. Consequently, no person may operate an aircraft to which an AD applies, except in accordance with the requirements of that AD, unless otherwise specified by the Agency [EC 2042/2003 Annex I, Part M.A.303] or agreed with the Authority of the State of Registry [EC 216/2008, Article 14(4) exemption].</p>		
<p>Design Approval Holder's Name: VULCANAIR S.p.A.</p>		<p>Type/Model designation(s): P.68 aeroplanes</p>

TCDS Number:	EASA.A.385	
Foreign AD:	Not applicable	
Supersedure:	This AD supersedes EASA AD 2014-0020 dated 20 January 2014.	
ATA 77	Engine Indicating System – Multifunction Engine Gauge – Insp

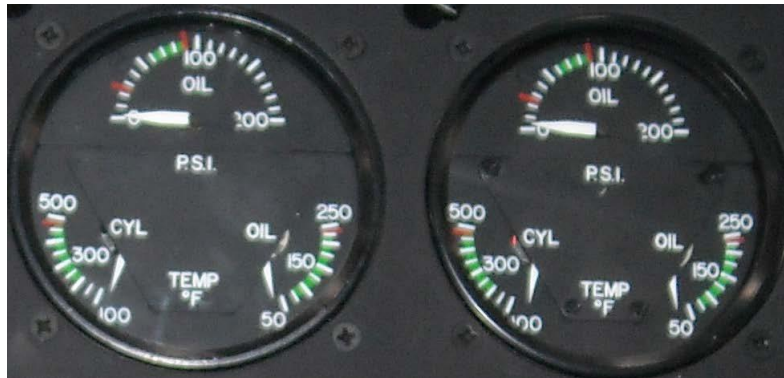
Figure 1. Correct configuration with Weston P/N 22-804-01-19A or A.I.D. P/N 18-1000-11

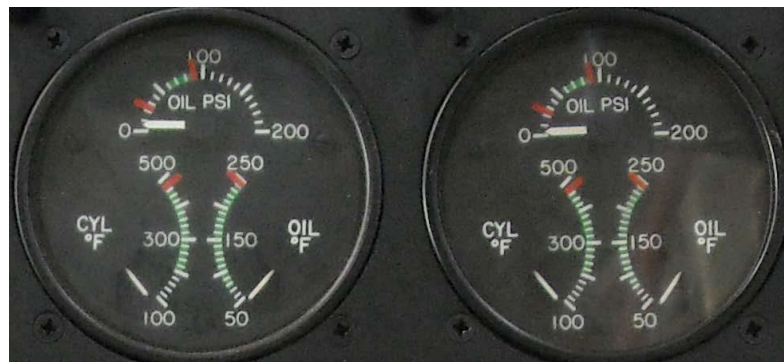
Figure 2. Correct configuration with Sigma Tek (Edo Aire) P/N 1U378-003-20, or P/N 1U378-003-20A
